6. PHASE II EVALUATION AND ASSESSMENT OF IMPACT AT ROCKLAND

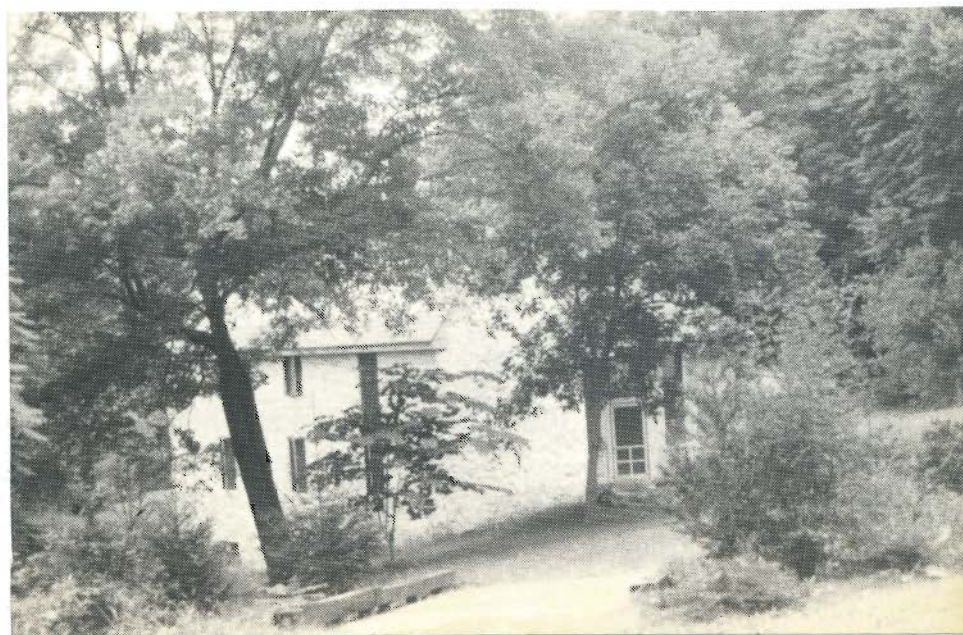
Plate 4

Stone
house
located
just above
the
project
right-of-way,
formerly
associated
with the mill

The upper part of the project area has been deeply filled to provide a level yard for a house served by the private drive at the top of the sketch map, Figure 6. This house, shown in Plate 4, while not in the project area, will be impacted visually by the project. A house appears on this location in the 1868 map but not in the 1849 map, which gives a good bracket for the construction date of the house.

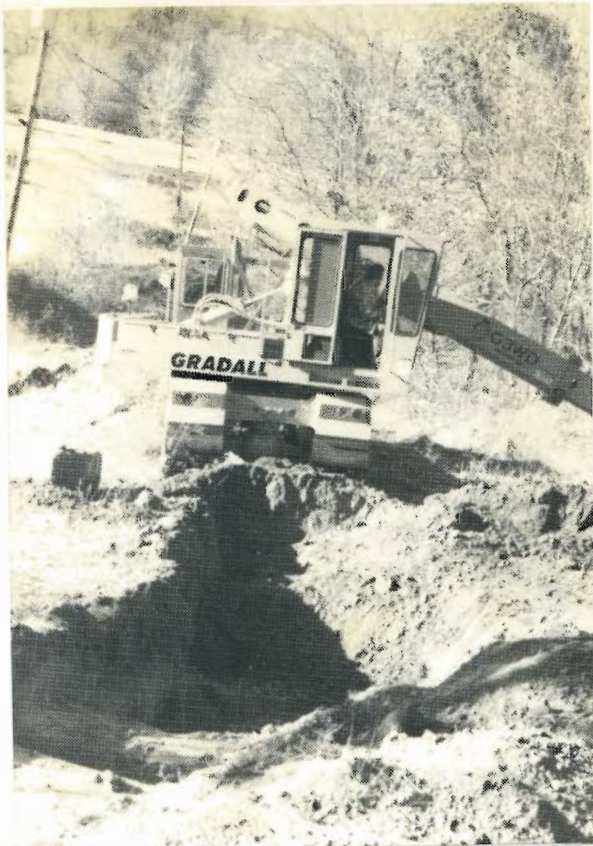
Figure 6

four-unit stone rowhouse buildings and a frame store. These buildings can easily be located on the historic maps, with some accuracy. On the ground their locations are not so easily discerned, since the whole area was covered with clean fill after the buildings were demolished (FIGURE 6). When the 1918 map (FIGURE 7) was compared to existing conditions, it was possible to pinpoint historical features that are known to have existed.

In the vicinity of the rowhouse units, Mount Lebanon Run is contained between stone walls. The ground is covered with building debris including brick and stone masonry fragments and wall sections. One part of a masonry foundation and the remains of a springhouse are visible in the underbrush.

The store site has been cleared and graded, leaving no surface indications. Along Rockland Road, the apparent depth of fill is as much as ten feet in places. In the store site is a large Wilmington water department underground complex of meters and other equipment, marked on the surface by three manholes. Informants identified the manholes as occupying the site of the store, which is confirmed by the map.

Sketch map
of Rockland
project area,
with notes on
existing field
conditions

Dates refer to the dates of maps or
illustrations on which the features in
question appear.

No further archaeological work is recommended for the area marked "heavily filled and disturbed" on figure 8. The house site, however, definitely warrants appropriate data-recovery treatment. The store site is apparently completely obliterated, and requires no further attention.

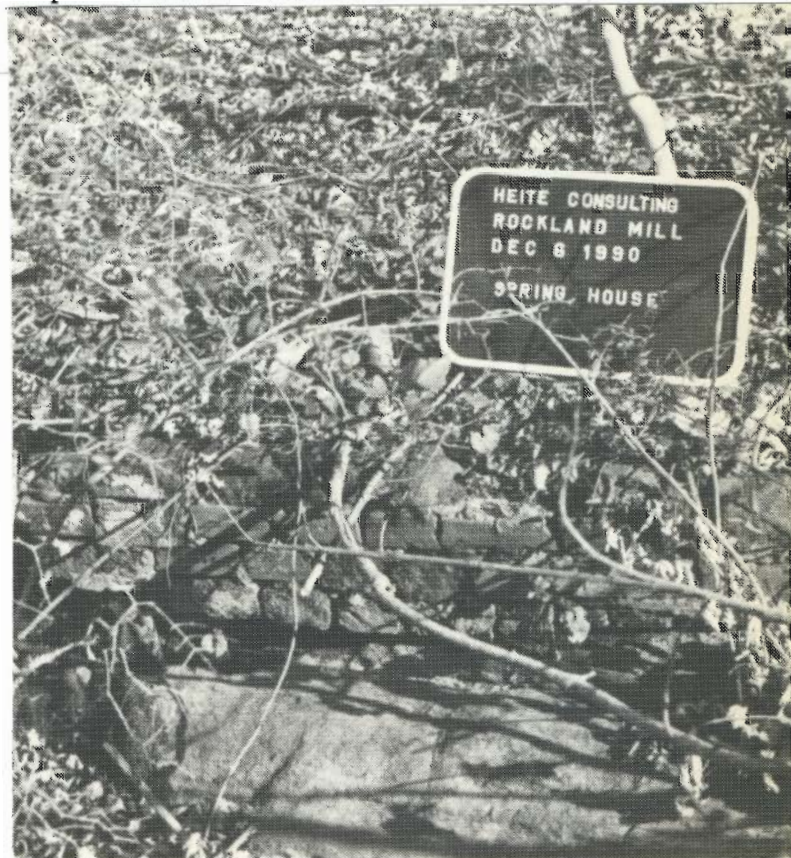
Plate 6

At the top of the rowhouse unit stands the ruin of a springhouse (PLATE 6), which was built on a large natural outcrop. Looking

Remains of the spring house

Longtime resident Burl Owens reported that the springhouse had not been used toward the last, since a deep dug well had replaced it.

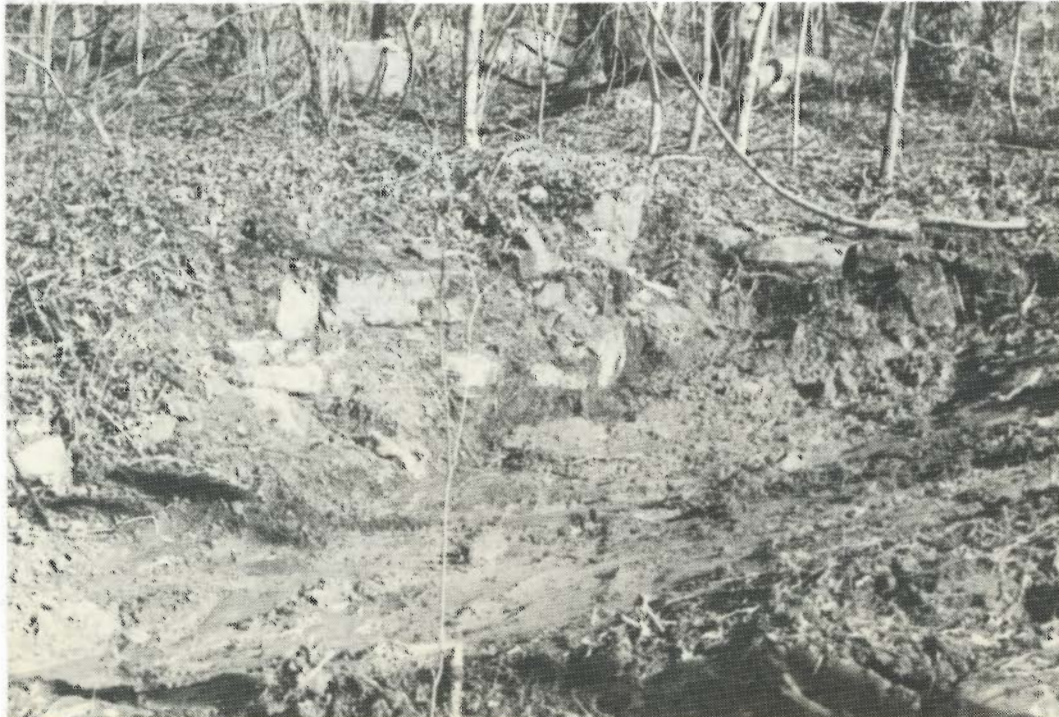
At the opposite end of this plateau, alongside the channel, a small fragment or mortared stone wall was visible. When the debris in front of this wall was removed, it proved to be standing forty inches above the muck of the channel leading from the spring.

Excavated wall segment,
looking northeast

The upper row of worker houses retains its archaeological integrity, but the lower row has been severely damaged. The wall shown on Plate 8 is part of a stone platform on which stood the upper block of row. It also retained the spring branch.

In the area tested, this drain ran along the foot of the wall from a springhouse, perpetually wetting the soil. Organic remains could be preserved in the wet area.

Since there was a high probability that the channel might contain undisturbed deposits, it was backfilled gently, leaving the wall segment visible above ground for future reference.

The current plan would have an adverse effect on these remains. If it is impossible to avoid disturbing the ruins, data recovery will be the preferred treatment.
